Appendix E

Photograph Log

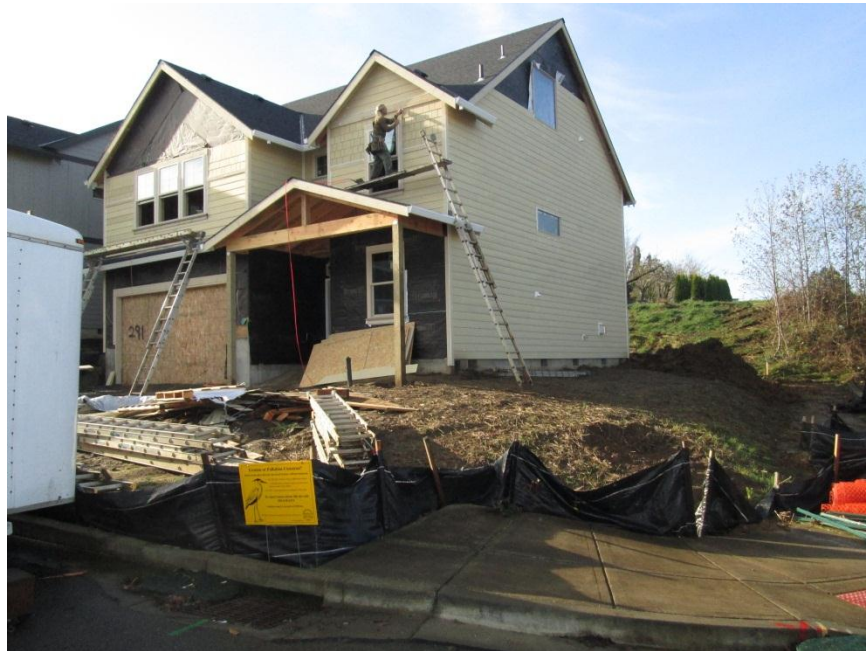
Photograph 8. Eastmont Estates Residential Development – View facing west of northern residential lot under construction.

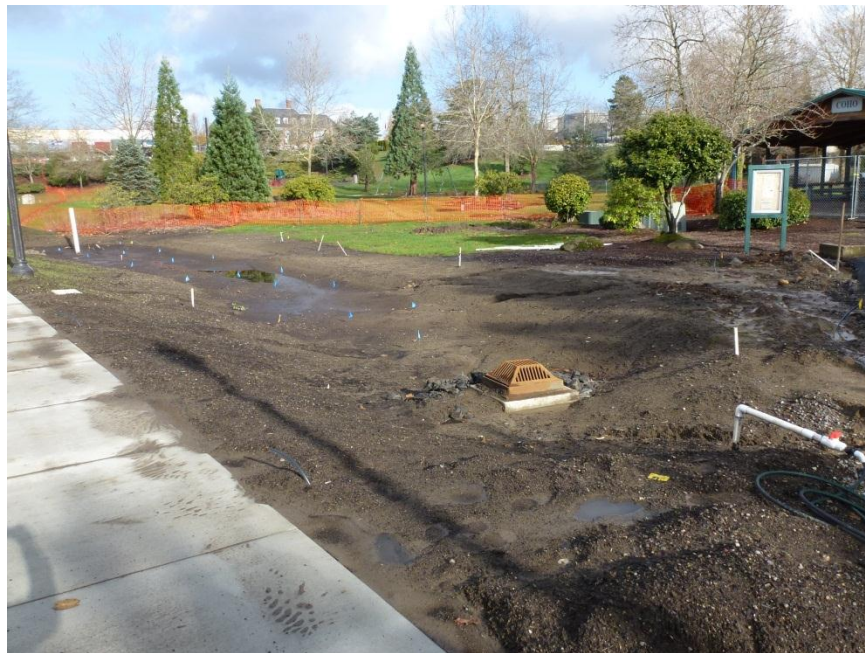
Photograph 18. Main City Park CIP Project – View facing northeast of City Park construction site.
